National Transportation Safety Board

Pipeline Operations Group Factual Report

**Natural Gas Fire
West Cote Blanche Bay
October 12, 2006
MAR07MM001**

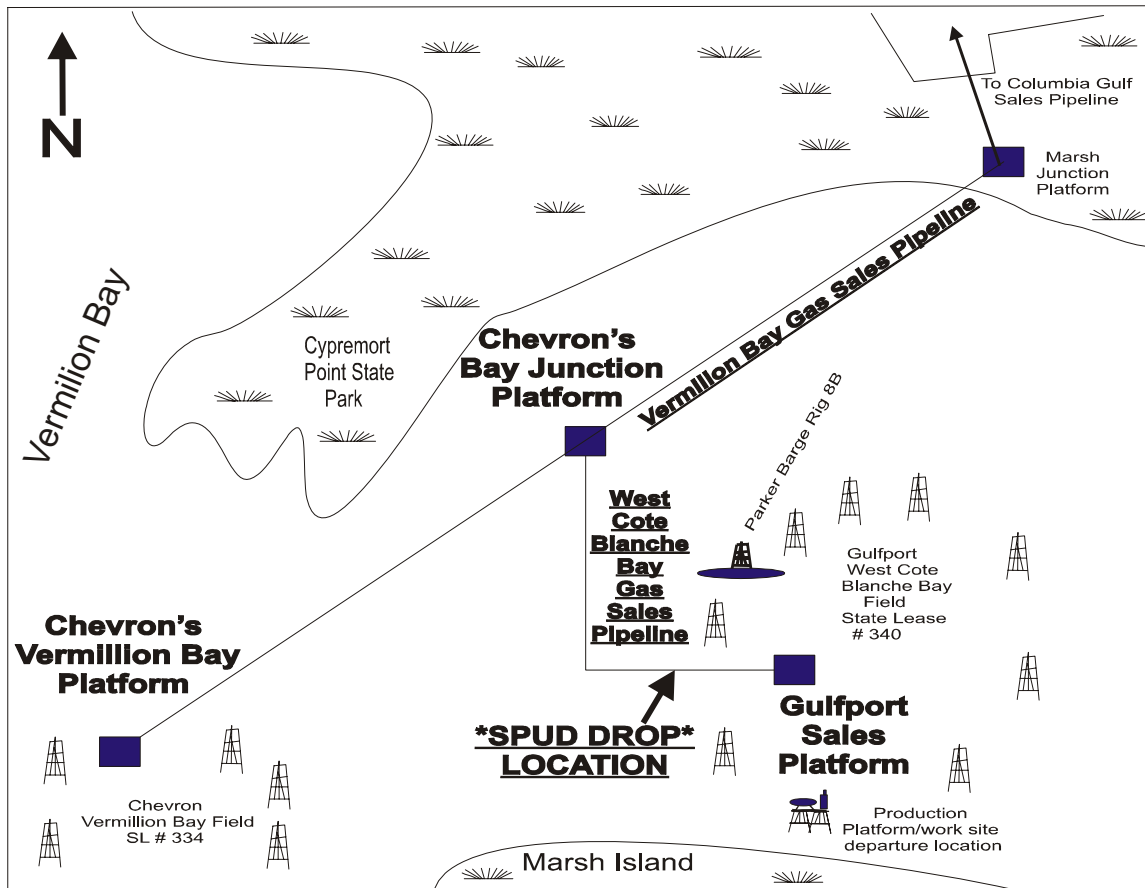
Figure 1. - Diagram of
Accident Site
Not to Scale

When the accident occurred, the tow and barges had departed from a production platform/work site on the south side of the West Cote Blanche Bay production field and were traveling around the outskirts of the field, which was owned and operated by Gulfport Energy Corporation (Gulfport). The intended destination of the vessels was a drilling barge known as Parker Barge Rig 8B, which was located on the northwest side of the field. The vessels had traveled about halfway to the destination when the spud accidentally dropped. The spud went through, about 7 feet of water and about 3 feet of mud and contacted the pipeline.

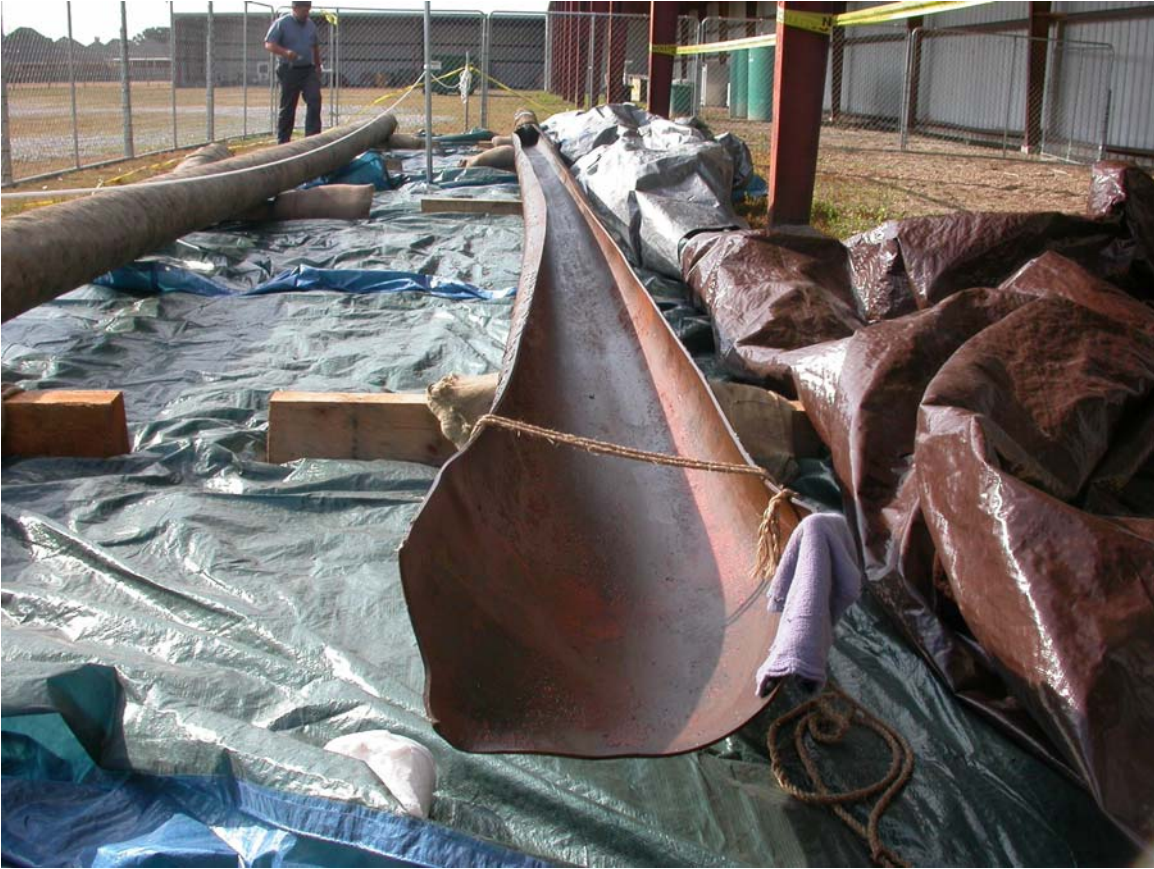
Picture of the Transverse Fracture on the East Piece of the Gas Sales Pipeline (Dent on pipe exterior not visible)

The Stress Engineering Services, Inc. report indicated that the “rupture event produced both a transverse fracture and a longitudinal fracture in the pipe. The transverse fracture was 2.1 feet to the East of a circumferential field girth weld located in the western piece of pipe. The longitudinal fracture extended from the transverse fracture to the East for 43.4 feet. The report identified a reversal in the direction of fracture surface markings and how the reversal “is consistent with a fracture origin area in the bend [in the longitudinal fracture surface].” The report also noted “Internal and external corrosion were insignificant.”
